**Subject: Selfs Point STP Expansion – Environmental Data Gap Analysis and Recommendations for Further Sampling**

This letter report details a review of previous site investigations completed at the site, a data gap analysis of those investigations in relation to the 50% concept design and recommendations for the assessment and management of potential contamination on site during construction works.

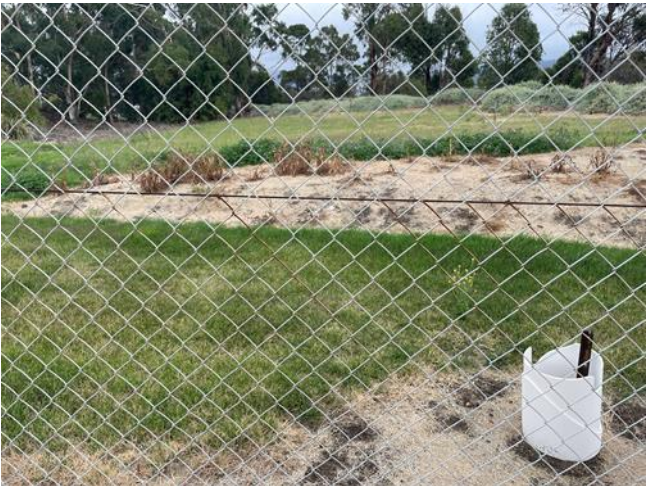
| Northern portion of 12 Selfs Point Road | |
|---|---|
| <p><b>Photo 1.</b> Photo looking south towards the STP. Groundwater well MW1 was located in the foreground with white plastic shield. Stockpiled material centre photo.</p> | |

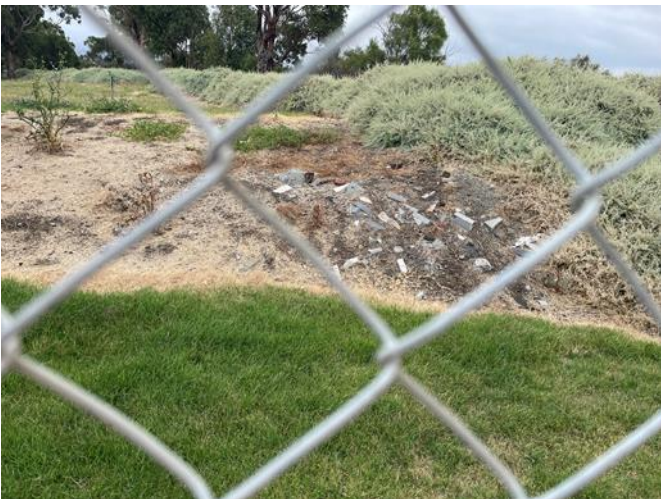
| Northern portion of 12 Selfs Point Road | |
|---|---|
| <p><b>Photo 2.</b> Photo looking south towards the STP. An example of stockpiled material in this area. Note presence of building waste.</p> | |

| Timing | Location | Media | Recommendations for Further Investigation |
|---|---|---|---|
| | Northern portion of 12 Selfs Point Road,<br>Council depot, 10 Selfs Point Road | Soil | Assessment of soil stockpiles by an appropriately qualified environmental consultant and classification for waste disposal or on-site re-use. Stockpile sampling would be based on the number and size of stockpiles, in accordance with IB105. Analytes would include contaminants identified during previous investigations (including the contaminants listed in Table 2 of IB105) and presence/absence for asbestos should suspected ACM be identified. |

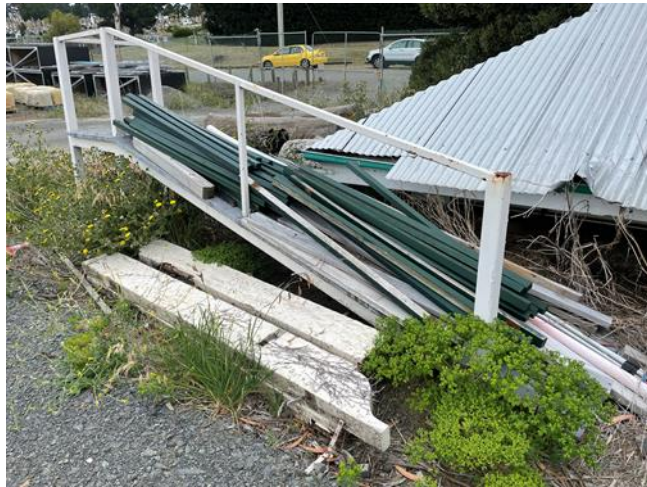
**Photo 3.** Photo looking east towards Selfs Point Road. Location of the roof and associated material. This was the vicinity of potential ACM identified.

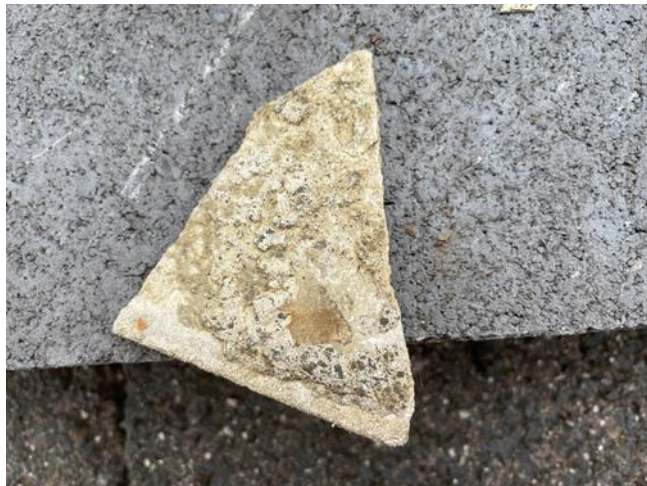
**Photo 4.** Potential ACM identified from Photo 3.

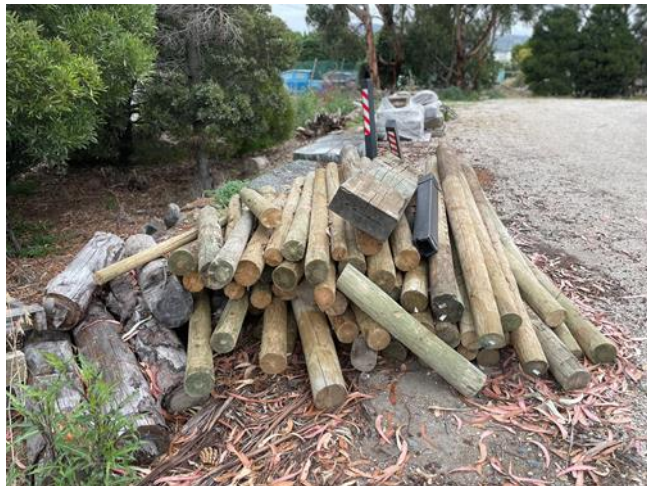
**Photo 5.** Photo looking south. Stockpile of treated pine logs. Other building material stockpiles included sandstone and concrete blocks, tiles, boulders, bricks and abandoned equipment.

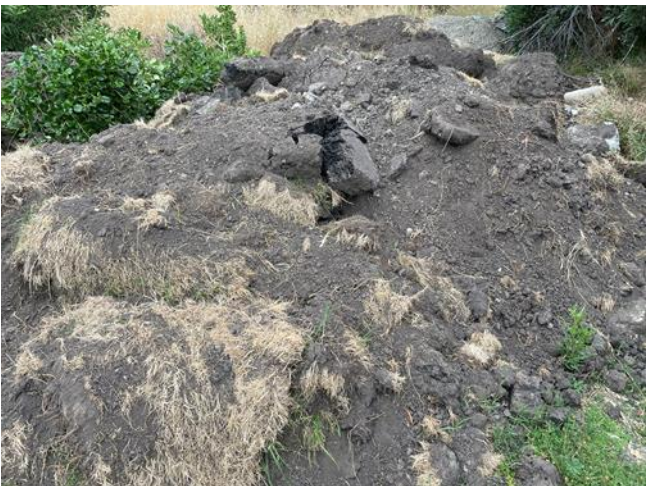
| <p><b>Photo 6.</b> Photo looking west towards the wetlands. Waste stockpile of soil, rock and bitumen.</p> | |

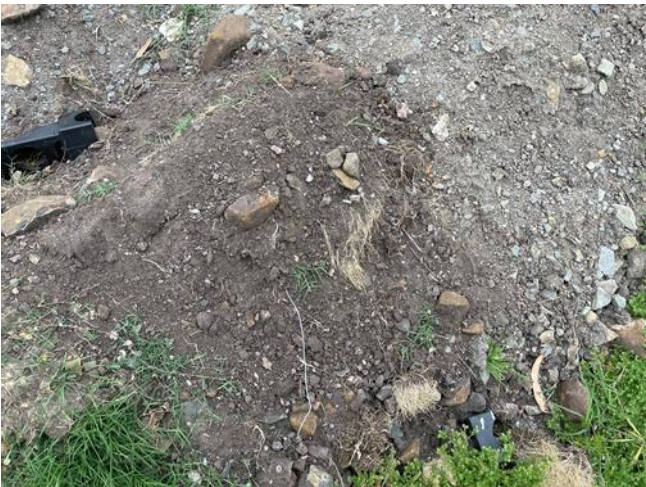
| <p><b>Photo 7.</b> Photo looking west towards the wetlands. Soil stockpile comprising rock, clay, sand and plastic.</p> | |

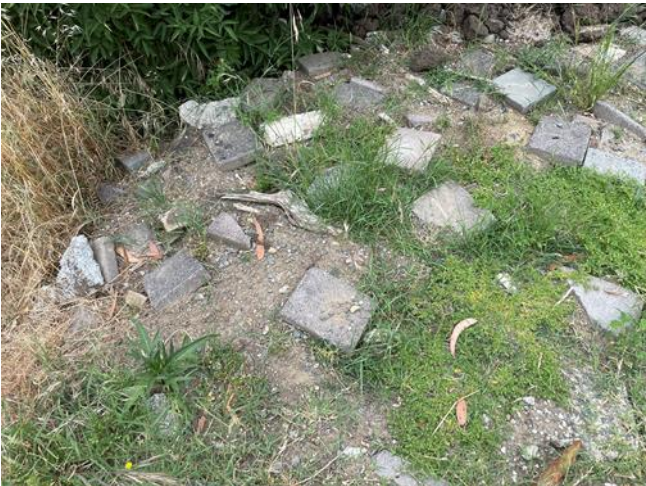
| <p><b>Photo 8.</b> Stockpile adjacent the Wetlands comprising, bricks, soil, gravel and concrete.</p> | |

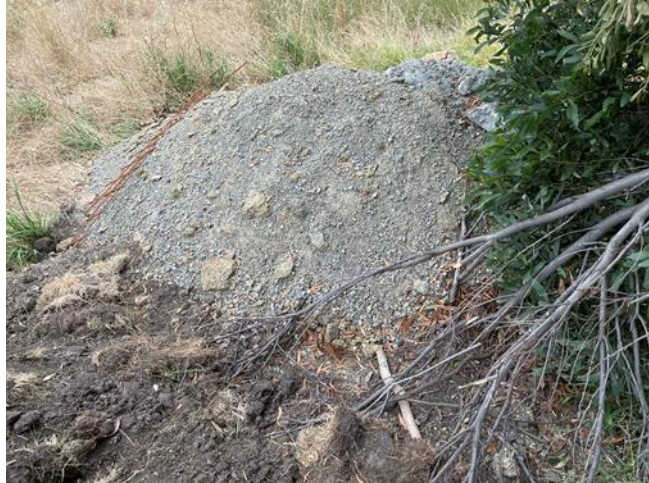
**Photo 9.** Stockpile adjacent the Wetlands (looking west), comprising gravel, soil, concrete and metal.

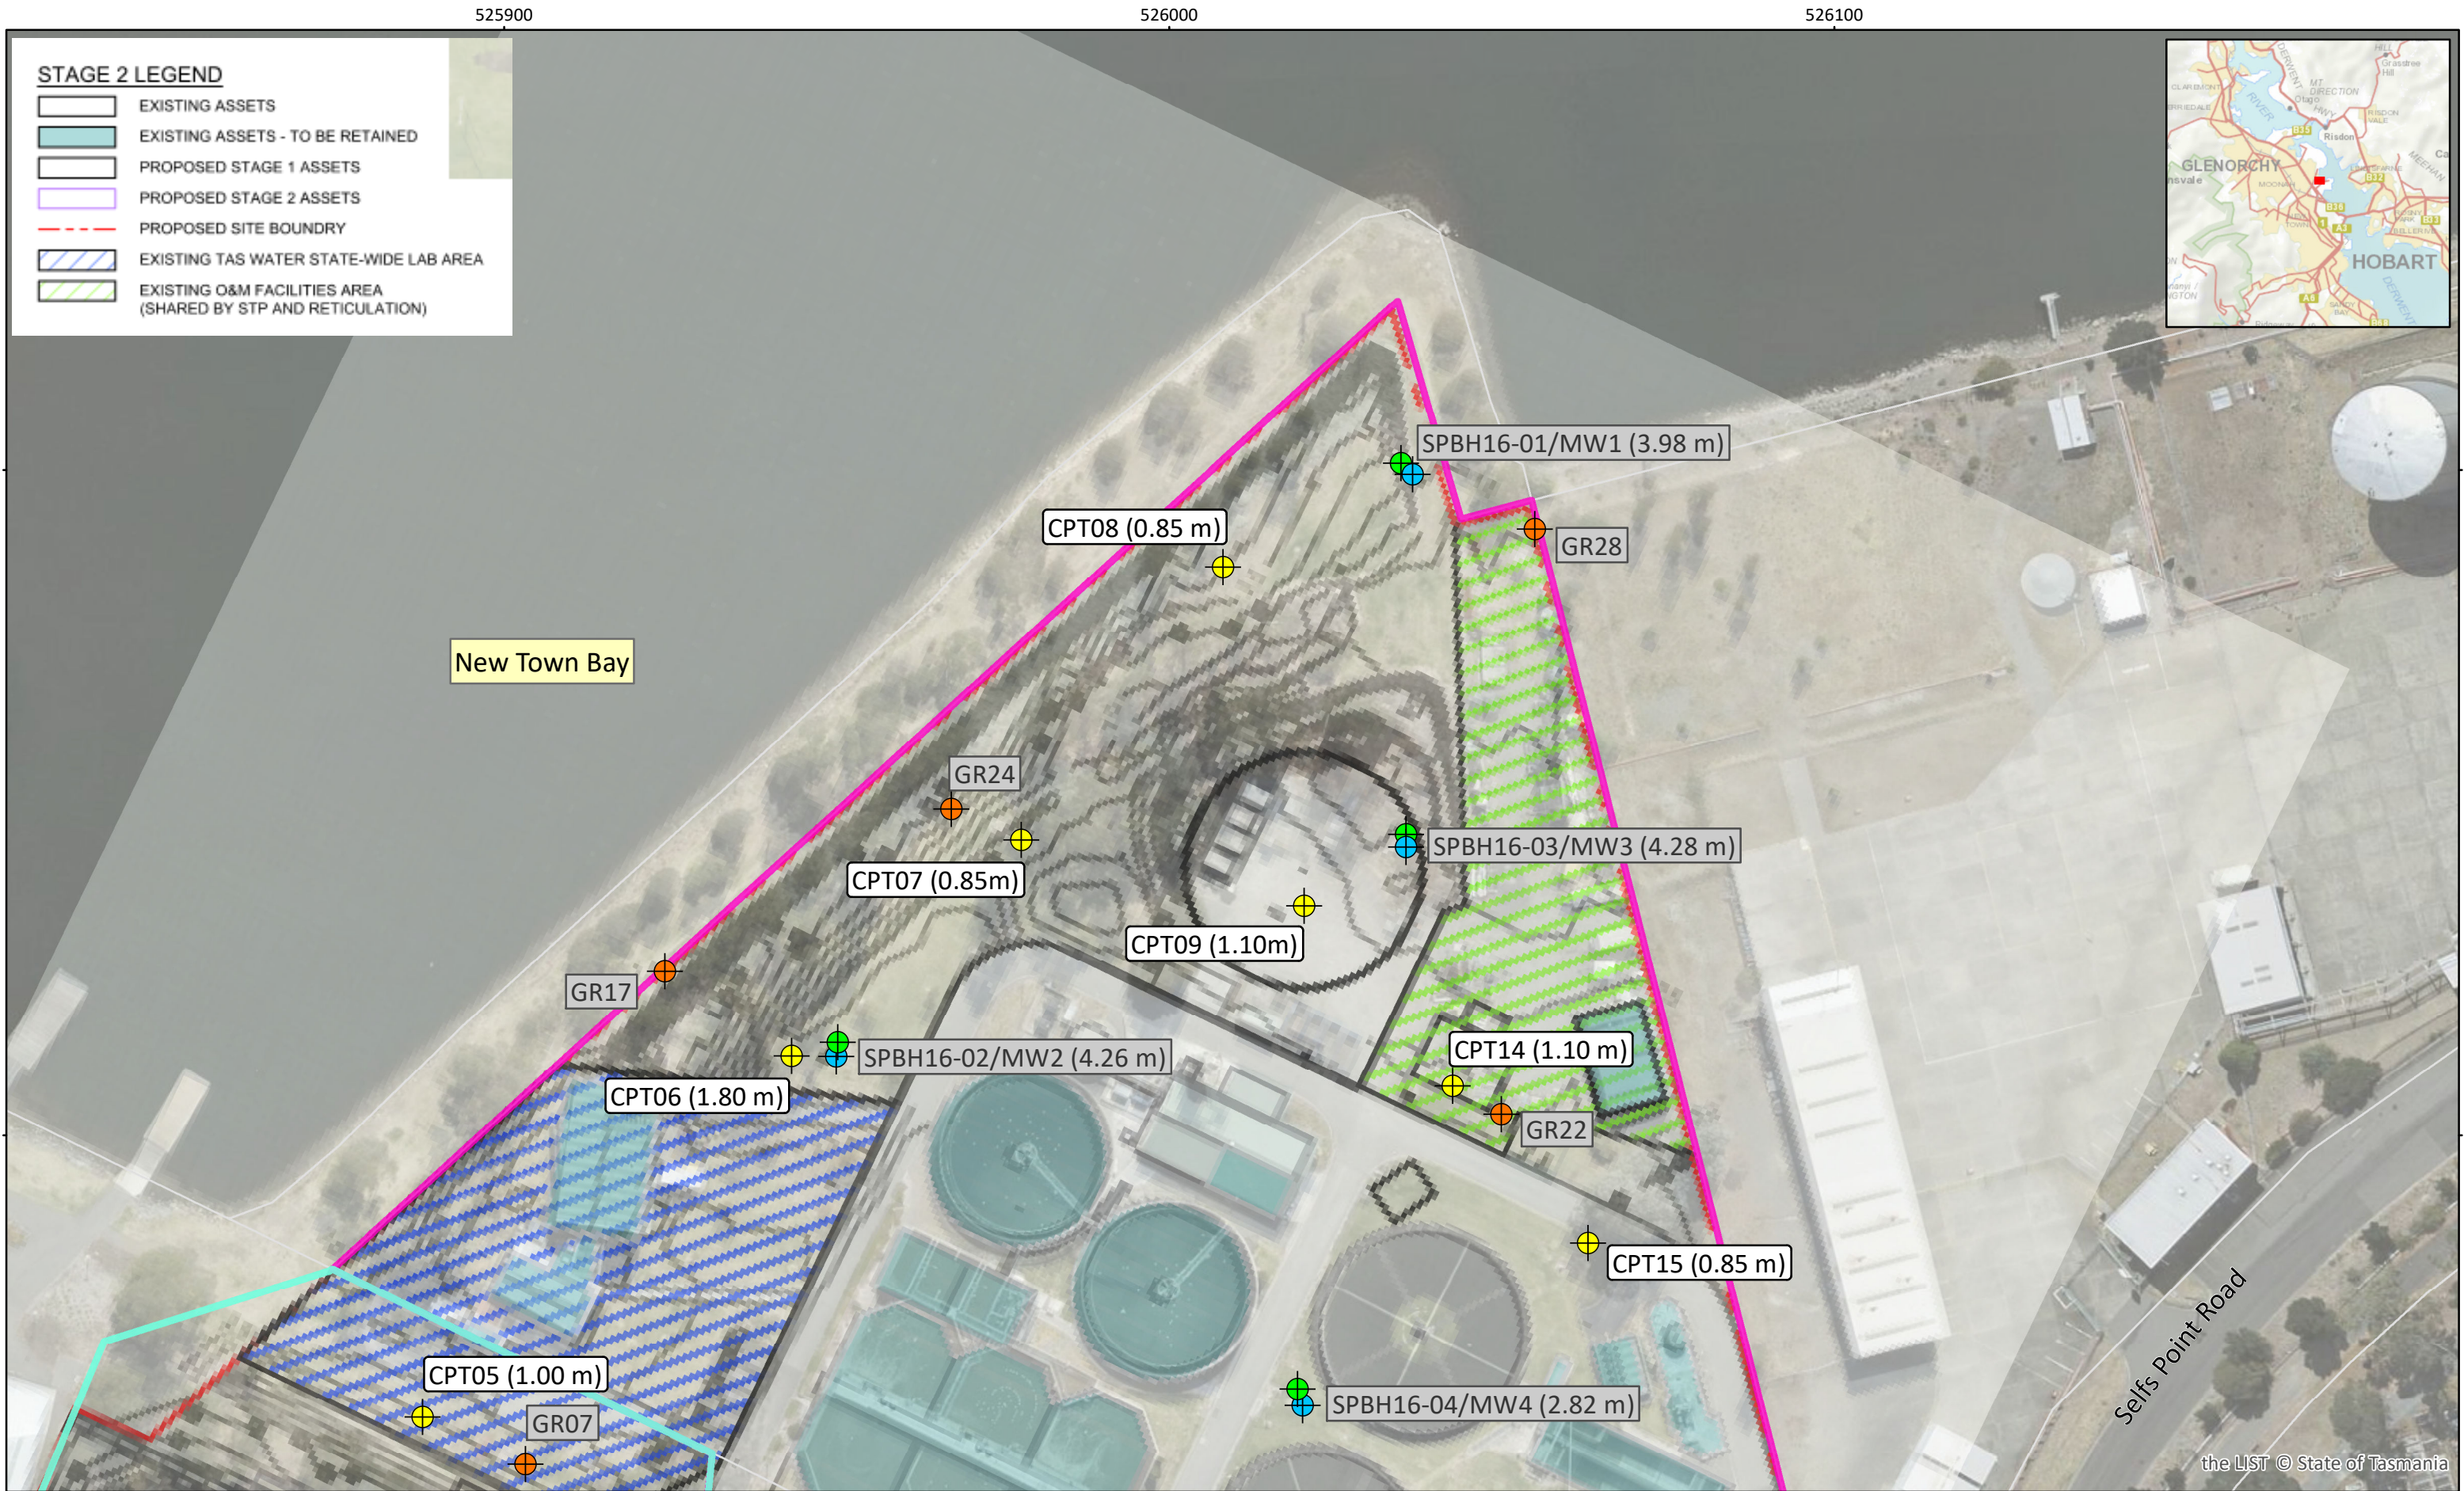
The locations of all investigations relevant to the 50% concept design are shown on attached **Figures 2 and 3**. Only the locations within, or in close proximity to the 50% concept design are discussed below.
